**Flood Control Project Maintenance
Levee Inspections**
LMA District Cover Sheet
Spring 2017 Levee Inspection Results

Reclamation District No. 2103 Wheatland Vicinity

Spring 2017 Levee Inspection Results

Waterway			Bank	Unit Miles
Unit No. 01 South Dry Creek			Left	4.64
	Spring (March - May)	Summer (June - August)	(September - November) Fall	Winter (December - February)
Unit Maintenance Rating (Fall Only)				
Date of Inspection	4/27/2017 - 4/27/2017			
DWR Inspector	Sterling York			
Accompanied By	Tom Engler RD 2103

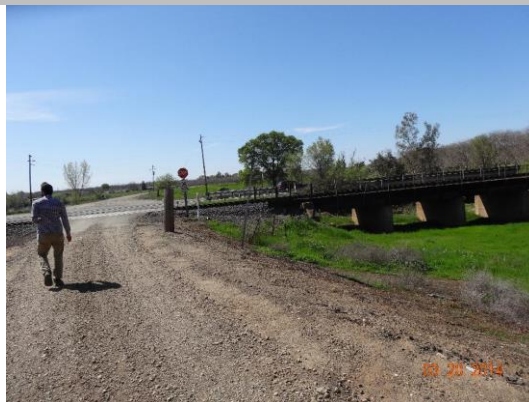
Photo 2 of 3 : UCIP_SP_2017_39987_71884.jpg

View of levee crown and waterward side.

LM Start	0.56	Rating **	M	Issue No.	32 (cont)
LM End	0.56	Issue Type +	En	Location *	LS
Category	Supplemental			GPS Latitude/Longitude	
				Start	End
Item	DWR UCIP Field Study			39.022665 °	39.022665 °
				-121.444688 °	-121.444688 °
DWR ID					
Comment Code					
Inspector Comment					
FS_ID:39987 DS_ID:24879 EP_NO: N/A Repair Type: Non-Urgent Crossing Status: Indicator Found UCIP Comments: Need to contact owner to obtain depth of line through levee. Also need permit authorizing conduit through levee. FIELD_STRUCT_DESC: Conduit line through levee. Markers visible on both sides. FS Date: 3/4/2014

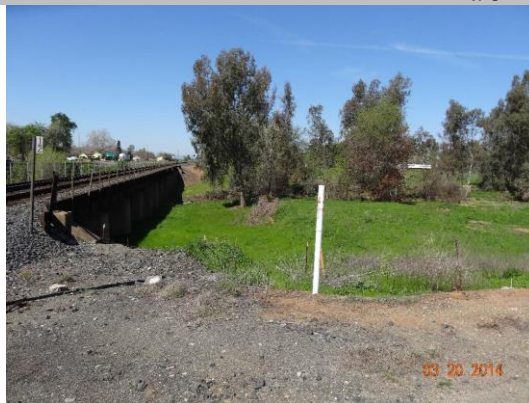
Photo 3 of 3 : UCIP_SP_2017_39987_71886.jpg

View of waterward side.

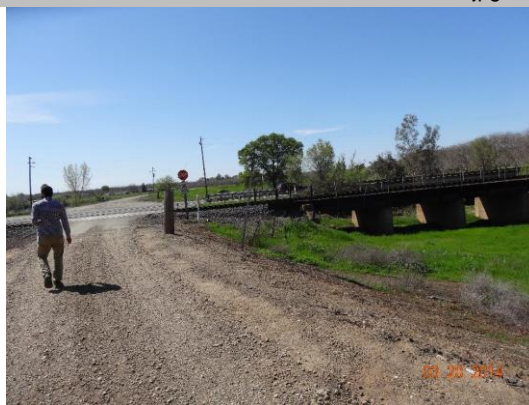
Photo 1 of 3 : UCIP_SP_2017_38323_69860.jpg

LM Start	0.56	Rating **	M	Issue No.	33
LM End	0.56	Issue Type +	En	Location *	LS
Category	Supplemental			GPS Latitude/Longitude	
				Start	End
Item	DWR UCIP Field Study			39.022733 °	39.022733 °
				-121.444626 °	-121.444626 °
DWR ID					
Comment Code					
Inspector Comment					
FS_ID:38323 DS_ID:19469 EP_NO: 2098 Repair Type: Non-Urgent Crossing Status: Indicator Found UCIP Comments: Need to contact owner to determine status of crossing. Need date of last inspection and confirmation that crossing is still in operable condition. FIELD_STRUCT_DESC: 16-inch steel gas line through the levee, 3.0 feet below the crown. Marker on waterward slope. (Permit No. 2098-1955). This entry matches the Drainage or Irrigation Structure referenced in O&M manual (HLM 0.56). FS Date: 3/20/2014

View of levee crown at crossing.

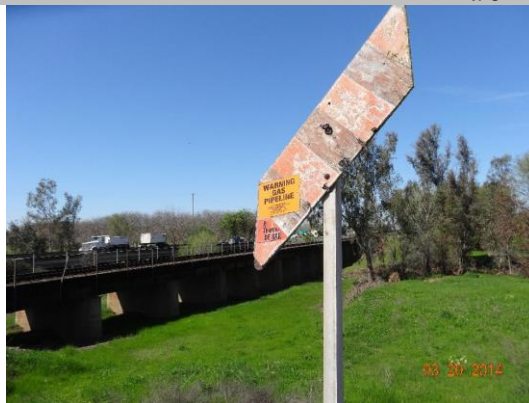
Photo 2 of 3 : UCIP_SP_2017_38323_69859.jpg

LM Start	0.56	Rating **	M	Issue No.	33 (cont)
LM End	0.56	Issue Type +	En	Location *	LS
Category	Supplemental			GPS Latitude/Longitude	
				Start	End
Item	DWR UCIP Field Study			39.022733 °	39.022733 °
				-121.444626 °	-121.444626 °
DWR ID					
Comment Code					
Inspector Comment					
FS_ID:38323 DS_ID:19469 EP_NO: 2098 Repair Type: Non-Urgent Crossing Status: Indicator Found UCIP Comments: Need to contact owner to determine status of crossing. Need date of last inspection and confirmation that crossing is still in operable condition. FIELD_STRUCT_DESC: 16-inch steel gas line through the levee, 3.0 feet below the crown. Marker on waterward slope. (Permit No. 2098-1955). This entry matches the Drainage or Irrigation Structure referenced in O&M manual (HLM 0.56). FS Date: 3/20/2014

Marker visible waterward side.

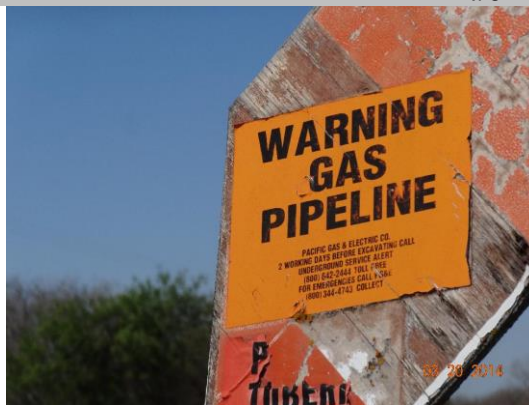
Photo 3 of 3 : UCIP_SP_2017_38323_69858.jpg

Contact information of owner.

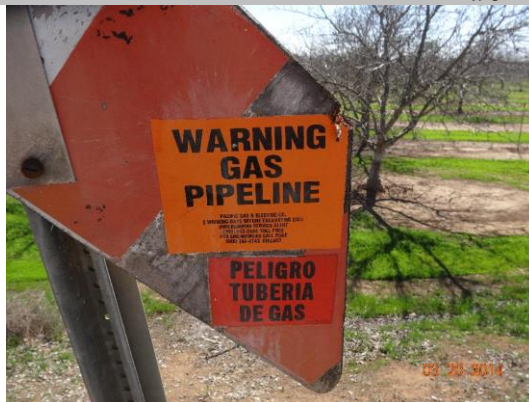
Photo 2 of 3 : UCIP_SP_2017_38324_69863.jpg

Comment Code					
Inspector Comment					
FS_ID:38324					
DS_ID:19470					
EP_NO: 789					
Repair Type: Non-Urgent					
Crossing Status: Indicator Found					
UCIP Comments: Need to contact owner to determine status of crossing. Need date of last inspection and confirmation that crossing is still in operable condition.					
FIELD_STRUCT_DESC: 16-inch steel gas line through levee, 3.0 feet below the crown. Concrete inspection chamber (24x18-inch with 4-inch walls) on the waterward shoulder, covered with dirt. Gas line marker on landward slope. Extends underneath Dry Creek channel, covered with concrete slab approx. 18-inches wide. (Permit No. 789-1939). This entry matches the Drainage or Irrigation Structure referenced in O&M manual (HLM 0.63).					
FS Date: 3/20/2014

Contact information for gas pipeline.

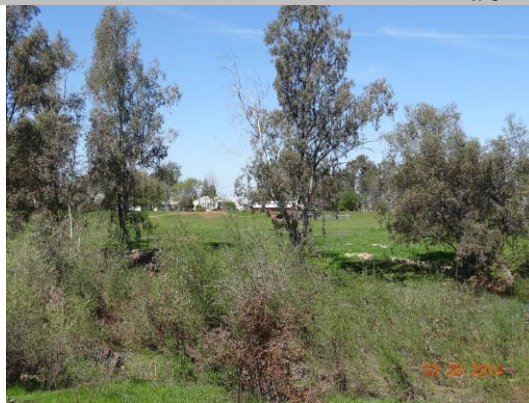
Photo 3 of 3 : UCIP_SP_2017_38324_69862.jpg

Comment Code						
Inspector Comment						
FS_ID:38324						
DS_ID:19470						
EP_NO: 789						
Repair Type: Non-Urgent						
Crossing Status: Indicator Found						
UCIP Comments: Need to contact owner to determine status of crossing. Need date of last inspection and confirmation that crossing is still in operable condition.						
FIELD_STRUCT_DESC: 16-inch steel gas line through levee, 3.0 feet below the crown. Concrete inspection chamber (24x18-inch with 4-inch walls) on the waterward shoulder, covered with dirt. Gas line marker on landward slope. Extends underneath Dry Creek channel, covered with concrete slab approx. 18-inches wide. (Permit No. 789-1939). This entry matches the Drainage or Irrigation Structure referenced in O&M manual (HLM 0.63).						
FS Date: 3/20/2014

Overview of gas marker visible on opposite bank.

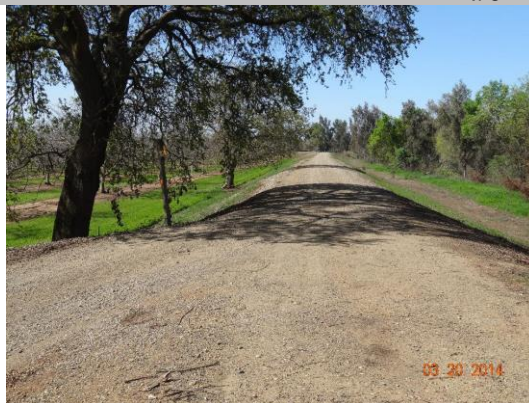
Photo 3 of 3 : UCIP_SP_2017_39988_71888.jpg

LM Start	0.81	Rating **	M	Issue No.	35 (cont)	
LM End	0.81	Issue Type +	En	Location *	LS	
Category	Supplemental			GPS Latitude/Longitude		
				Start	End	
Item	DWR UCIP Field Study			39.024725 °	39.024725 °	
				-121.440978 °	-121.440978 °	
DWR ID						
Comment Code						
Inspector Comment						
FS_ID:39988						
DS_ID:24880						
EP_NO: N/A						
Repair Type: Non-Urgent						
Crossing Status: Indicator Found						
UCIP Comments: No marker found on waterward side--need to confirm with owner if crossing goes through levee. If so, need depth of crossing through levee. Also need to obtain permit number used to authorize crossing.						
FIELD_STRUCT_DESC: Conduit line through levee. Marker visible on landward side.						
FS Date: 3/4/2014

View of levee at crossing.

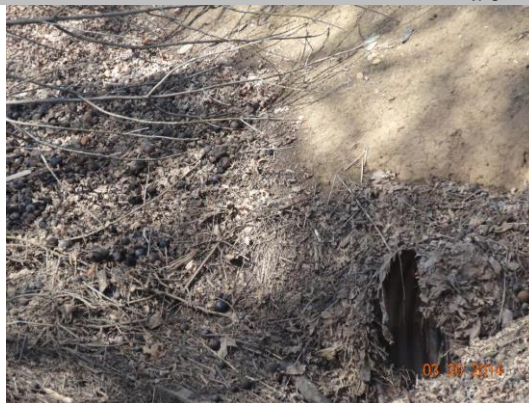
Photo 2 of 3 : UCIP_SP_2017_38325_69868.jpg

LM Start	0.82	Rating **	A/W	Issue No.	36 (cont)
LM End	0.82	Issue Type +	Ma	Location *	LS
Category	Supplemental			GPS Latitude/Longitude	
				Start	End
Item	DWR UCIP LMA Responsibility			39.024811 °	39.024811 °
				-121.440750 °	-121.440750 °
DWR ID					
Comment Code					
Inspector Comment					
FS_ID:38325					
DS_ID:19471					
EP_NO: N/A					
Repair Type: No Action Needed					
Crossing Status: Found					
UCIP Comments:					
FIELD_STRUCT_DESC: 36-inch CM drainpipe through the levee, 14.4 feet below the crown. Concrete headwall, flap-gate and 3x6-foot concrete splash apron at waterward toe. Outfall drain from old Grasshopper Slough. (USACE-1962). This entry matches the Drainage or Irrigation Structure referenced in O&M manual (HLM 0.83).					
FS Date: 3/20/2014

Close up view of crossing from landward side.

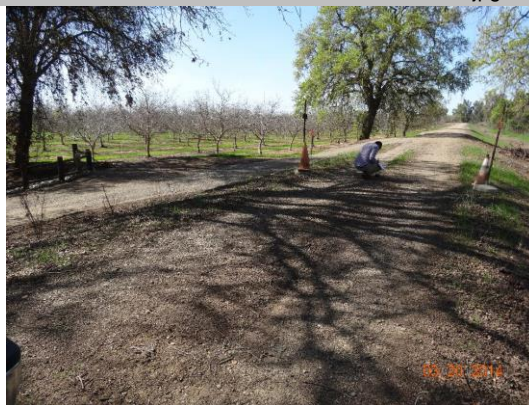
Photo 3 of 3 : UCIP_SP_2017_38325_69873.jpg

View of levee crown at crossing.

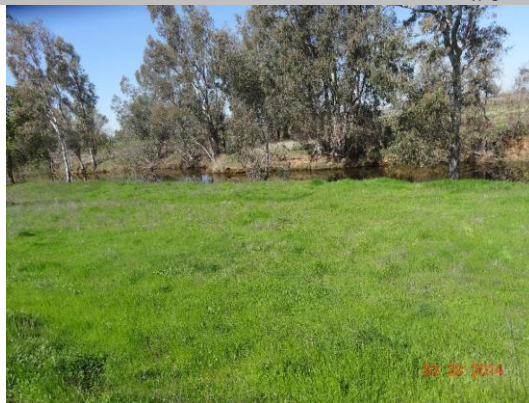
Photo 2 of 3 : UCIP_SP_2017_41183_69916.jpg

FS_ID:41183
DS_ID:19473
EP_NO: 1886
Repair Type: Non-Urgent
Crossing Status: Indicator Found
UCIP Comments: Need to coordinate with owner. Severely corroded section of steel pipe present on waterward side--no other evidence present at this location. Owner will need to coordinate with CVFPB and DWR-Inspector to determine proper action to abandon crossing.
FIELD_STRUCT_DESC: "ABANDONED" 12-inch steel irrigation pipe through the levee, 3.1 feet below the crown. Siphon breaker on the waterward slope. Concrete standpipe at the landward toe. Vertical pump on waterward side. Open on waterward end. Permit includes gravel dam through channel of Dry Creek. (Permit No. 1886-1959). This entry matches the Drainage or Irrigation Structure referenced in O&M manual (HLM 1.86). Crossing is angled 45 degrees.
FS Date: 3/20/2014

View of waterward side.

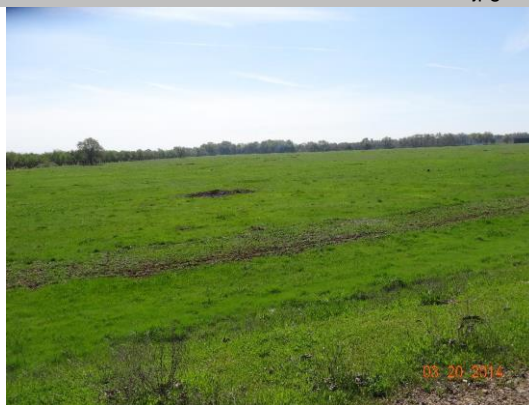
Photo 3 of 3 : UCIP_SP_2017_41183_69915.jpg

View of landward side.

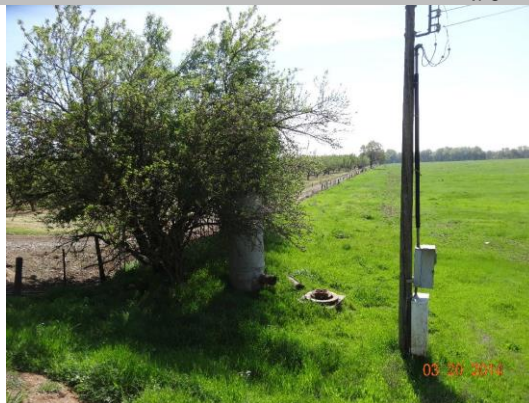
Photo 1 of 3 : UCIP_SP_2017_38327_69881.jpg

LM Start	1.86	Rating **	M	Issue No.	38
LM End	1.86	Issue Type +	En	Location *	LS
Category	Supplemental			GPS Latitude/Longitude	
				Start	End
Item	DWR UCIP Field Study			39.029694 °	39.029694 °
				-121.423946 °	-121.423946 °
DWR ID					
Comment Code					
Inspector Comment					
FS_ID:38327					
DS_ID:19512					
EP_NO: N/A					
Repair Type: Non-Urgent					
Crossing Status: Indicator Found					
UCIP Comments: Unable to determine if there is a crossing through pipe. Will need to coordinate with owner to determine additional information about appurtenances found on landward side.					
FIELD_STRUCT_DESC: Irrigation pump, service pole, and 36-inch concrete standpipe, 5 feet from the landward toe. No pump was found during field visit 3/20/14.					
FS Date: 3/20/2014

View of landward side.

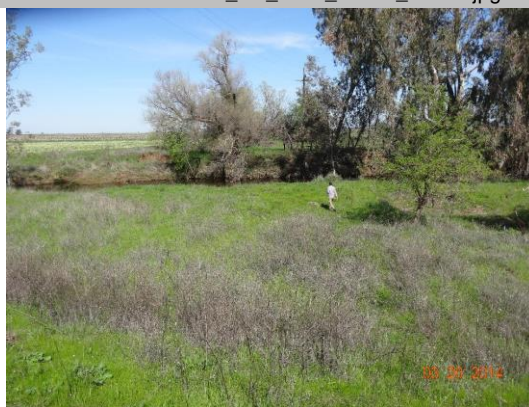
Photo 2 of 3 : UCIP_SP_2017_38327_69880.jpg

View of waterward side.

LM Start	1.86	Rating **	M	Issue No.	38 (cont)	
LM End	1.86	Issue Type +	En	Location *	LS	
Category	Supplemental			GPS Latitude/Longitude		
				Start	End	
Item	DWR UCIP Field Study			39.029694 °	39.029694 °	
				-121.423946 °	-121.423946 °	
DWR ID						
Comment Code						
Inspector Comment						
FS_ID:38327						
DS_ID:19512						
EP_NO: N/A						
Repair Type: Non-Urgent						
Crossing Status: Indicator Found						
UCIP Comments: Unable to determine if there is a crossing through pipe. Will need to coordinate with owner to determine additional information about appurtenances found on landward side.						
FIELD_STRUCT_DESC: Irrigation pump, service pole, and 36-inch concrete standpipe, 5 feet from the landward toe. No pump was found during field visit 3/20/14.						
FS Date: 3/20/2014

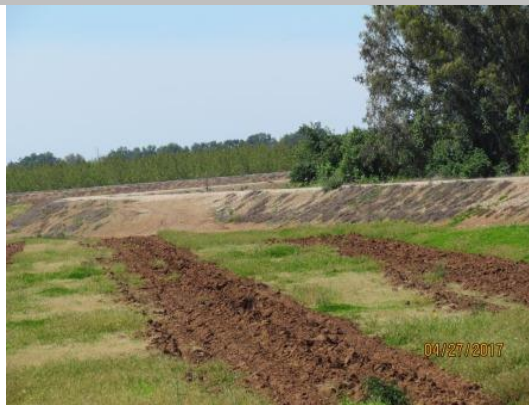
Photo 1 of 1 : SP_2017_RD2103_10_19_20170428_00045.jpg

LM Start	1.86	Rating **	A	Issue No.	19
LM End	4.45	Issue Type +	Ma	Location *	LS
Category	Earthen Levee			GPS Latitude/Longitude	
				Start	End
Item	Vegetation			39.029689 °	39.041419 °
				-121.423792 °	-121.394391 °
DWR ID	DWR_RD2103_01_s_2017_19				
Comment Code					
V1 : Control annual grass and weeds on the levee slopes and easements.					
Inspector Comment					
Annual vegetation that is well maintained, Spring 2017.

View looking downstream of annual vegetation that is well maintained, Spring 2017.

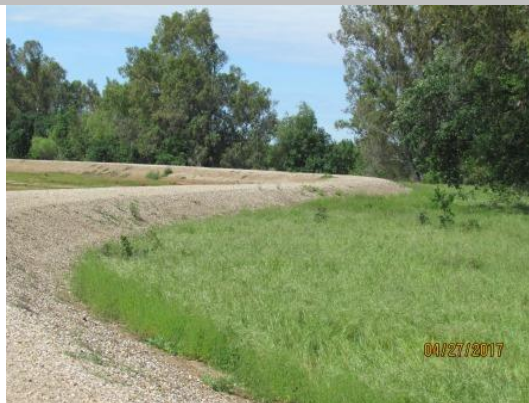
Photo 1 of 1 : SP_2017_RD2103_10_21_20170428_00046.jpg

LM Start	1.87	Rating **	A	Issue No.	21
LM End	4.45	Issue Type +	Ma	Location *	WS
Category	Earthen Levee			GPS Latitude/Longitude	
				Start	End
Item	Vegetation			39.029689 °	39.041414 °
				-121.423769 °	-121.394389 °
DWR ID	DWR_RD2103_01_s_2017_21				
Comment Code					
V1 : Control annual grass and weeds on the levee slopes and easements.					
Inspector Comment					
Annual vegetation that is well maintained, Spring 2017.

View looking downstream of annual vegetation that is well maintained, Spring 2017.

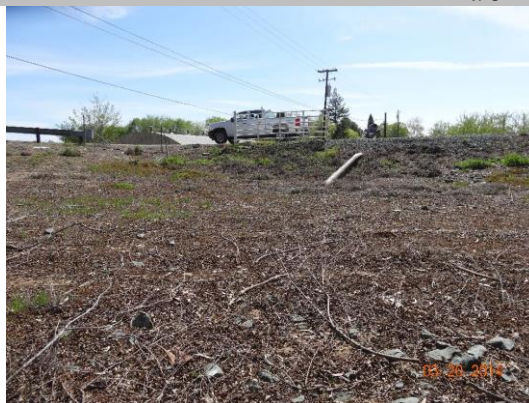
Photo 1 of 3 : UCIP_SP_2017_38331_69894.jpg

LM Start	2.64	Rating **	M	Issue No.	39
LM End	2.64	Issue Type +	En	Location *	WS
Category	Supplemental			GPS Latitude/Longitude	
				Start	End
Item	DWR UCIP Field Study			39.031590 °	39.031590 °
				-121.409870 °	-121.409870 °
DWR ID					
Comment Code					
Inspector Comment					
FS_ID:38331					
DS_ID:19477					
EP_NO: N/A					
Repair Type: Non-Urgent					
Crossing Status: Found					
UCIP Comments: Need to contact owner to determine status.					
FIELD_STRUCT_DESC: 8-inch steel irrigation pipe through the levee, 3.1 feet below the crown. Siphon breaker on the waterward slope.					
Pump on the landward side. Pipe crosses creek to orchard on north side (Permit No. 1887, 1954. (USACE-1962). This entry matches the Drainage or Irrigation Structure referenced in O&M manual (HLM 2.68).					
FS Date: 3/20/2014

View of waterward side.

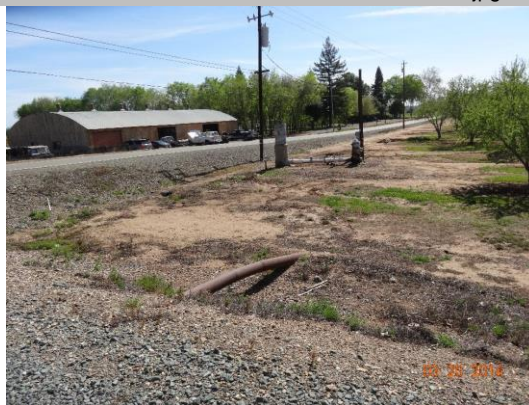
Photo 3 of 3 : UCIP_SP_2017_38331_69892.jpg

LM Start	2.64	Rating **	M	Issue No.	39 (cont)	
LM End	2.64	Issue Type +	En	Location *	WS	
Category	Supplemental			GPS Latitude/Longitude		
				Start	End	
Item	DWR UCIP Field Study			39.031590 °	39.031590 °	
				-121.409870 °	-121.409870 °	
DWR ID						
Comment Code						
Inspector Comment						
FS_ID:38331						
DS_ID:19477						
EP_NO: N/A						
Repair Type: Non-Urgent						
Crossing Status: Found						
UCIP Comments: Need to contact owner to determine status.						
FIELD_STRUCT_DESC: 8-inch steel irrigation pipe through the levee,						
3.1 feet below the crown. Siphon breaker on the waterward slope.						
Pump on the landward side. Pipe crosses creek to orchard on north						
side (Permit No. 1887, 1954. (USACE-1962). This entry matches the						
Drainage or Irrigation Structure referenced in O&M manual (HLM 2.68).						
FS Date: 3/20/2014

View of landward side.

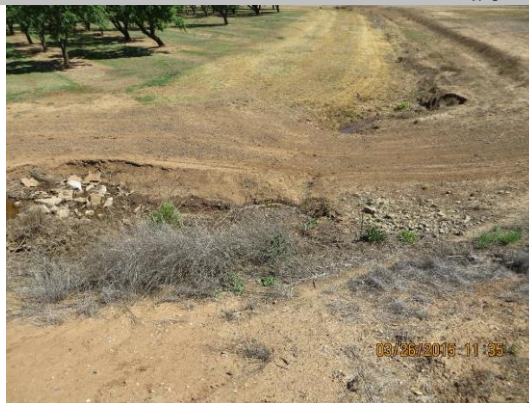
Photo 3 of 3 : UCIP_SP_2017_50033_73427.jpg

Comment Code						
Inspector Comment						
FS_ID:50033 DS_ID:19478 EP_NO: N/A Repair Type: Urgent Crossing Status: Found UCIP Comments: 7/08/2016 Meet with Tom Engler from MBK Engineers, District Engineer, and the District is in the process of trying to deauthorize portion of Unit 1. This section of the levee protects an orchard--levee is approximately 3-4 feet tall. (DWR UCIP - omagana)3/26/2015 Flapgate open and won't close due to vegetation and soil blocking its operation. (DWR UCIP - omagana) FIELD_STRUCT_DESC: 24-inch corrugated metal drainage pipe through the levee, 12 feet below the crown. Flap gate is located on the waterside (WS) end. [Additional Reference(s): DWR Levee Log, 2005]. FS Date: 7/8/2016 11:37:00 AM

Pipe visible at LS toe.

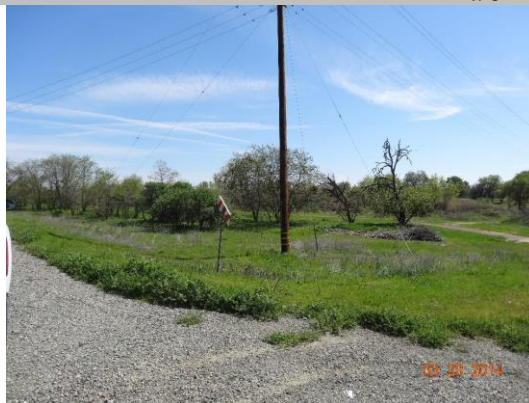
Photo 1 of 2 : UCIP_SP_2017_39992_69914.jpg

LM Start	1.26	Rating **	M	Issue No.	25
LM End	1.26	Issue Type +	En	Location *	WS
Category	Supplemental			GPS Latitude/Longitude	
				Start	End
Item	DWR UCIP Field Study			38.998301 °	38.998301 °
				-121.415296 °	-121.415296 °
DWR ID					
Comment Code					
Inspector Comment					
FS_ID:39992					
DS_ID:19484					
EP_NO: 1613					
Repair Type: Non-Urgent					
Crossing Status: Indicator Found					
UCIP Comments: Need to contact owner to determine status of crossing. Need date of last inspection and confirmation that crossing is still in operable condition.					
FIELD_STRUCT_DESC: 16-inch steel gas line through the levee, 3.0 feet below the crown. (Permit No. 1613-1951). This entry matches the Drainage or Irrigation Structure referenced in O&M manual (HLM 1.30).					
FS Date: 3/20/2014

Marker visible on waterward side.

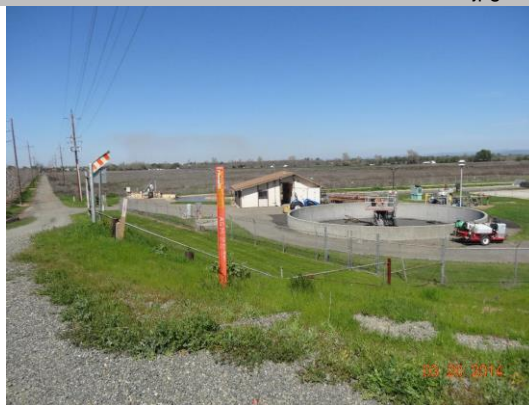
Photo 2 of 2 : UCIP_SP_2017_39992_69913.jpg

Marker visible on landward side.

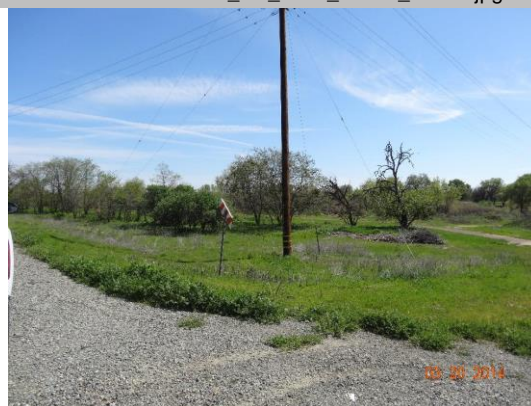
Photo 1 of 2 : UCIP_SP_2017_39993_69912.jpg

Comment Code					
Inspector Comment					
FS_ID:39993					
DS_ID:19486					
EP_NO: 5714					
Repair Type: Non-Urgent					
Crossing Status: Indicator Found					
UCIP Comments: Need to contact owner to confirm crossing and determine status.					
FIELD_STRUCT_DESC: 12-inch steel sewer pipes through the levee, 3.1 feet below the crown. Siphon breaker in 24-inch CM pipe riser on the landward shoulder. Standard CM cutoff wall around pipe at centerline of levee. Extends from wastewater treatment plant on landward side to waste water lagoon on waterward side. Permit includes construction of lagoon with surrounding short levee, extending from/to project levee. (Permit No. 5714-1968).					
FS Date: 3/20/2014

View of waterward side.

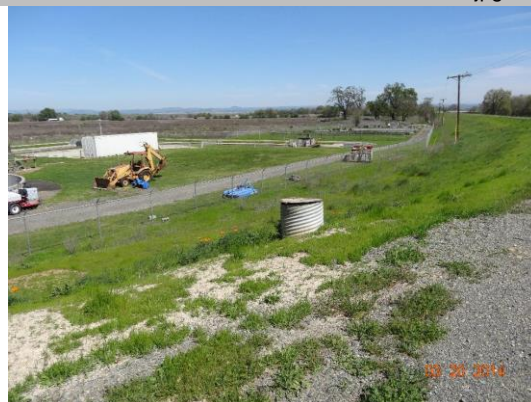
Photo 2 of 2 : UCIP_SP_2017_39993_69911.jpg

CMP riser located on landward side.

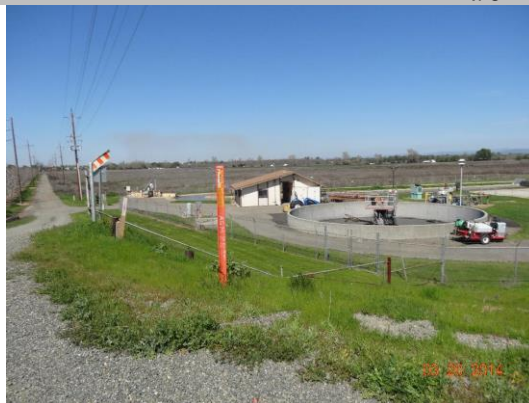
Photo 3 of 3 : UCIP_SP_2017_39994_69903.jpg

LM Start	1.29	Rating **	M	Issue No.	27 (cont)
LM End	1.29	Issue Type +	En	Location *	WS
Category	Supplemental			GPS Latitude/Longitude	
				Start	End
Item	DWR UCIP Field Study			38.998322 °	38.998322 °
				-121.414688 °	-121.414688 °
DWR ID					
Comment Code					
Inspector Comment					
FS_ID:39994					
DS_ID:19509					
EP_NO: N/A					
Repair Type: Non-Urgent					
Crossing Status: Indicator Found					
UCIP Comments: Need to contact owner to determine details of the crossing through levee.					
FIELD_STRUCT_DESC: Wheatland Sewage Disposal Plant on waterward side, treatment plant on landward side. Service pole on waterward slope.					
FS Date: 3/20/2014

View of water treatment located on landward side, photo 2 of 3.

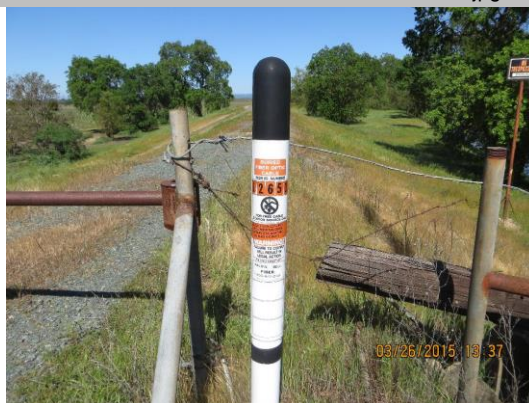
Photo 1 of 3 : UCIP_SP_2017_44089_73568.jpg

LM Start	1.76	Rating **	M	Issue No.	28
LM End	1.76	Issue Type +	En	Location *	WS
Category	Supplemental			GPS Latitude/Longitude	
				Start	End
Item	DWR UCIP Field Study			39.000557 °	39.000557 °
				-121.406581 °	-121.406581 °
DWR ID					
Comment Code					
Inspector Comment					
FS_ID:44089 DS_ID:25090 EP_NO: N/A Repair Type: Non-Urgent Crossing Status: Found UCIP Comments: No permit identified for this crossing. FIELD_STRUCT_DESC: Fiberoptic line through the levee at unknown depth. Marker visible on WS shoulder. 6-inch steel pipe visible on upstream side of railroad trestle. FS Date: 3/26/2015

Fiberoptic line marker on crown of levee

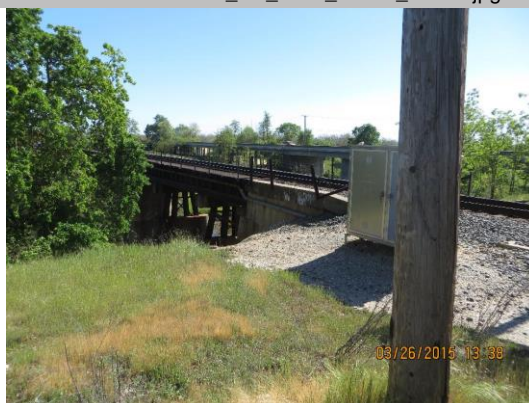
Photo 2 of 3 : UCIP_SP_2017_44089_73567.jpg

LM Start	1.76	Rating **	M	Issue No.	28 (cont)	
LM End	1.76	Issue Type +	En	Location *	WS	
Category	Supplemental			GPS Latitude/Longitude		
				Start		End
Item	DWR UCIP Field Study			39.000557 °		39.000557 °
				-121.406581 °		-121.406581 °
DWR ID						
Comment Code						
Inspector Comment						
FS_ID:44089						
DS_ID:25090						
EP_NO: N/A						
Repair Type: Non-Urgent						
Crossing Status: Found						
UCIP Comments: No permit identified for this crossing.						
FIELD_STRUCT_DESC: Fiberoptic line through the levee at unknown depth. Marker visible on WS shoulder. 6-inch steel pipe visible on upstream side of railroad trestle.						
FS Date: 3/26/2015

6-inch steel conduit visible on upstream side of railroad bridge.

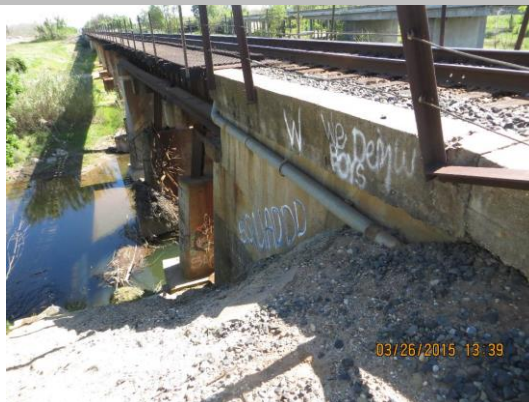
Photo 3 of 3 : UCIP_SP_2017_44089_73566.jpg

6-inch steel conduit visible on upstream side of railroad bridge.

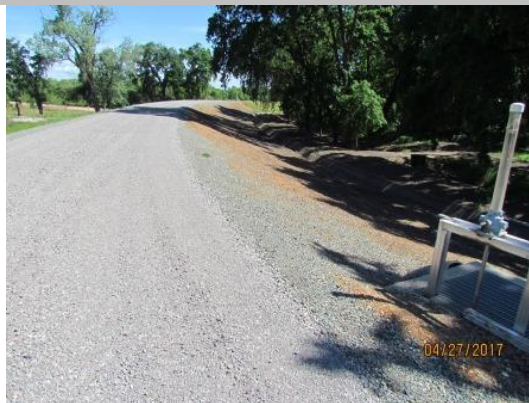
Photo 1 of 1 : SP_2017_RD2103_11_13_20170428_00033.jpg

LM Start	2.59	Rating **	A	Issue No.	13
LM End	2.67	Issue Type +	Ma	Location *	WS
Category	Earthen Levee			GPS Latitude/Longitude	
				Start	End
Item	Vegetation			39.009335 °	39.010327 °
				-121.397305 °	-121.396597 °
DWR ID	DWR_RD2103_02_s_2017_13				
Comment Code					
V1 : Control annual grass and weeds on the levee slopes and easements.					
Inspector Comment					
Well maintained annual vegetation, Spring 2017.

View looking upstream of the annual vegetation that is well maintained, Spring 2017.

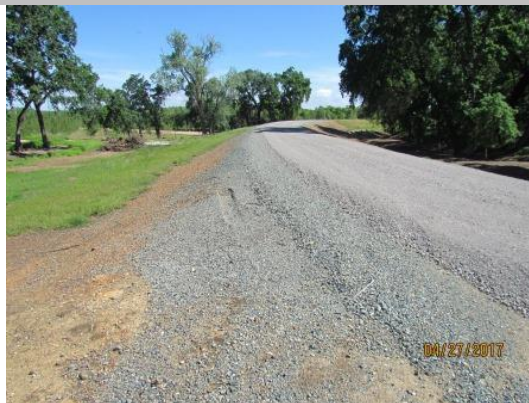
Photo 1 of 1 : SP_2017_RD2103_11_12_20170428_00034.jpg

LM Start	2.60	Rating **	A	Issue No.	12
LM End	2.67	Issue Type +	Ma	Location *	LS
Category	Earthen Levee			GPS Latitude/Longitude	
				Start	End
Item	Vegetation			39.009348 °	39.010327 °
				-121.397312 °	-121.396597 °
DWR ID	DWR_RD2103_02_s_2017_12				
Comment Code					
V1 : Control annual grass and weeds on the levee slopes and easements.					
Inspector Comment					
Well maintained annual vegetation, Spring 2017.

View looking upstream of the annual vegetation that is well maintained, Spring 2017.

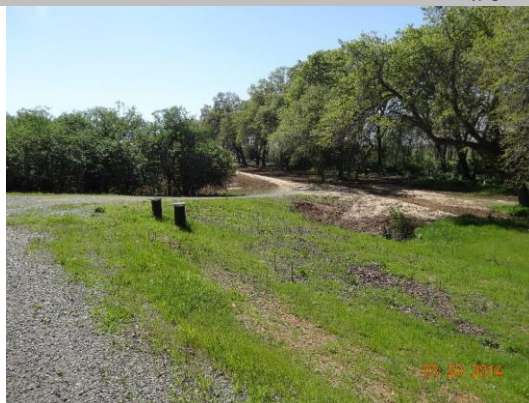
Photo 1 of 3 : UCIP_SP_2017_40045_71908.jpg

LM Start	2.60	Rating **	M	Issue No.	29
LM End	2.60	Issue Type +	En	Location *	LS
Category	Supplemental			GPS Latitude/Longitude	
				Start	End
Item	DWR UCIP Field Study			39.009394 °	39.009394 °
				-121.397300 °	-121.397300 °
DWR ID					
Comment Code					
Inspector Comment					
FS_ID:40045 DS_ID:19488 EP_NO: N/A Repair Type: Non-Urgent Crossing Status: Found UCIP Comments: Pipe has been plugged--visible on landward side. Need to contact owner to obtain additional information about abandoned crossing. FIELD_STRUCT_DESC: 1 of 2: 30-inch diameter CM irrigation pipe through levee, 13.8 feet below crown. Slide gates in 42-diameter riser on waterward slope. Concrete "U" headwall at both levee toes. Grouted spillway on landward side. (USACE-1962). This entry matches the Drainage or Irrigation Structure referenced in O&M manual (HLM 2.67). FS Date: 3/20/2014

View of waterward shoulder.

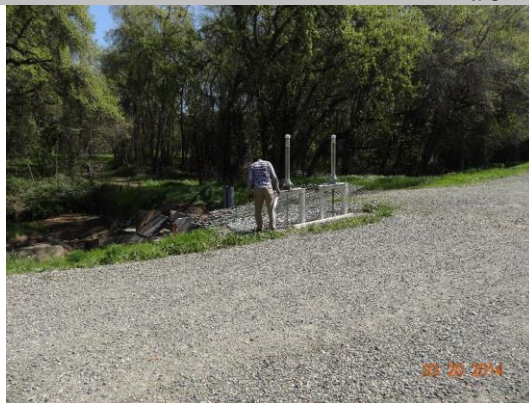
Photo 2 of 3 : UCIP_SP_2017_40045_71907.jpg

Slide gates visible located on landward side.

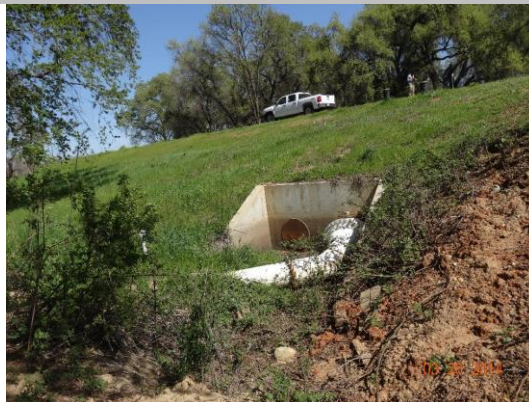
Photo 3 of 3 : UCIP_SP_2017_40045_71912.jpg

View of waterward side.

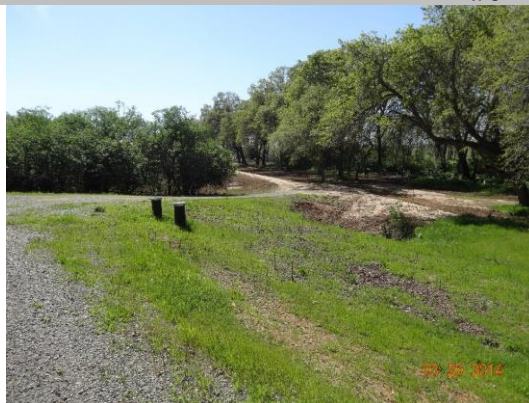
Photo 1 of 3 : UCIP_SP_2017_40046_71915.jpg

LM Start	2.60	Rating **	M	Issue No.	30
LM End	2.60	Issue Type +	En	Location *	LS
Category	Supplemental			GPS Latitude/Longitude	
				Start	End
Item	DWR UCIP Field Study			39.009408 °	39.009408 °
				-121.397296 °	-121.397296 °
DWR ID					
Comment Code					
Inspector Comment					
FS_ID:40046 DS_ID:19504 EP_NO: N/A Repair Type: Non-Urgent Crossing Status: Found UCIP Comments: Need to contact owner to determine status--crossing appears to be modified. Need to contact owner to obtain additional information about modified crossing. FIELD_STRUCT_DESC: 2 of 2: 30-inch diameter CM irrigation pipe through levee, 13.8 feet below crown. Slide gates in 42-diameter riser on waterward slope. Concrete "U" headwall at both levee toes. Grouted spillway on landward side. (USACE-1962). This entry matches the Drainage or Irrigation Structure referenced in O&M manual (HLM 2.67). FS Date: 3/20/2014

View of waterward side.

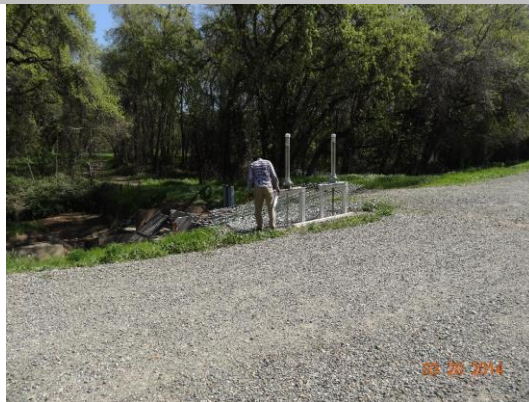
Photo 2 of 3 : UCIP_SP_2017_40046_71914.jpg

View of landward side.

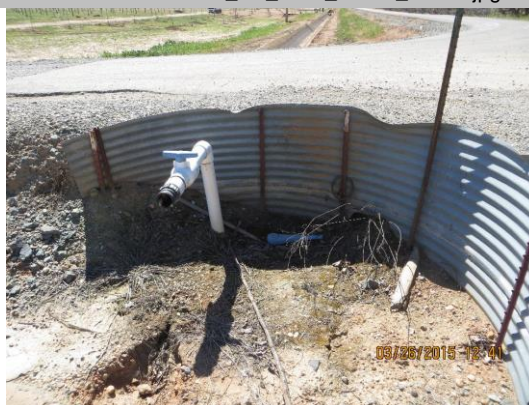
Photo 1 of 2 : UCIP_SP_2017_43957_73435.jpg

LM Start	3.94	Rating **	M	Issue No.	31
LM End	3.94	Issue Type +	En	Location *	WS
Category	Supplemental			GPS Latitude/Longitude	
				Start	End
Item	DWR UCIP Field Study			39.022486 °	39.022486 °
				-121.379343 °	-121.379343 °
DWR ID					
Comment Code					
Inspector Comment					
FS_ID:43957 DS_ID:19500 EP_NO: N/A Repair Type: Non-Urgent Crossing Status: Indicator Found UCIP Comments: Further evaluation necessary to determine alignment of crossing should be conducted. FIELD_STRUCT_DESC: 4-inch PVC water line through levee, 6-feet below the levee crown. Ball valve and Service connection point on LS shoulder. Pipe appears to run parallel to east, on LS slope just off crown but may cross at this location as well. An O+M entry matches the size and location for this crossing (O&M manual 1962, (HLM 4.05). FS Date: 3/26/2015

Service connection and ball valve visible on LS shoulder.

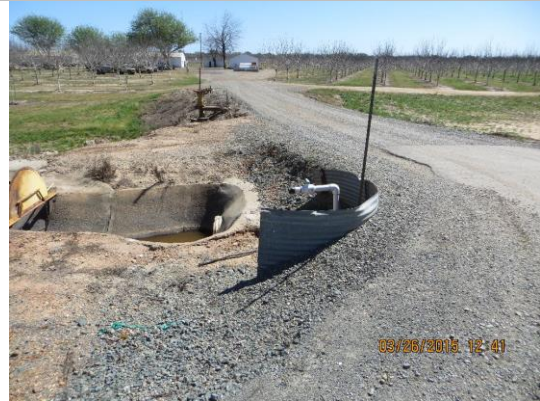
Photo 2 of 2 : UCIP_SP_2017_43957_73434.jpg

Service connection and ball valve visible on LS shoulder.

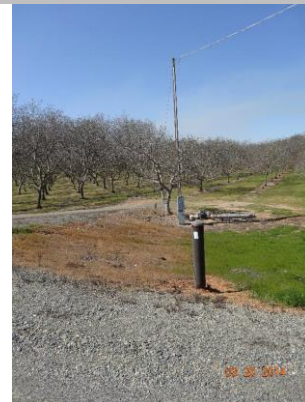
Photo 1 of 3 : UCIP_SP_2017_40048_71922.jpg

Comment Code					
Inspector Comment					
FS_ID:40048 DS_ID:19510 EP_NO: N/A Repair Type: Non-Urgent Crossing Status: Found UCIP Comments: Crossing has been modified---need to contact owner to obtain permit used for modification. FIELD_STRUCT_DESC: 24-inch CM irrigation pipe through the levee, 8.0 feet below the crown. Slide gate in concrete square riser (not CM pipe riser as mentioned in desk study) on waterward slope. Concrete headwall and trash rack at toe of waterward slope. Breather pipe on landward slope. Dischare in irrigation ditch on landward side. Two CM cutoff walls. (USACE-1962). This entry matches the Drainage or Irrigation Structure referenced in O&M manual (HLM 4.05). Replaced by multiple CM irrigation pipes under Permit No. 18081 (2006). FS Date: 3/20/2014

View of waterward side.

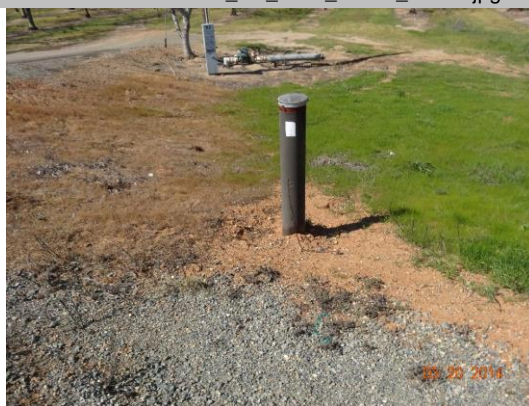
Photo 2 of 3 : UCIP_SP_2017_40048_71921.jpg

Riser located on landward slope.

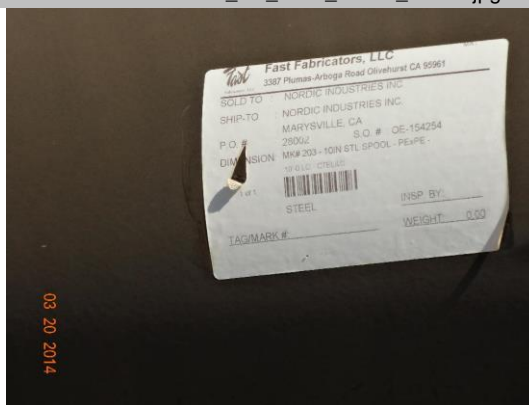
Photo 3 of 3 : UCIP_SP_2017_40048_71920.jpg

Label on riser.

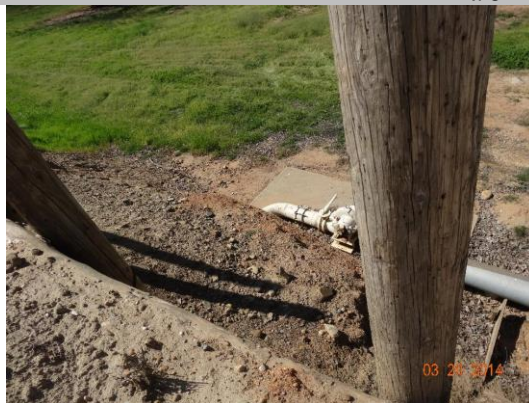
Photo 1 of 3 : UCIP_SP_2017_40049_71928.jpg

FS_ID:40049
DS_ID:19493
EP_NO: N/A
Repair Type: Non-Urgent
Crossing Status: Found
UCIP Comments: Crossing has been modified---need to contact owner to obtain permit used for modification.
FIELD_STRUCT_DESC: 24-inch corrugated metal irrigation pipe through levee, 10.6 feet below the crown. Slide gate in concrete square riser (not 36-inch CM riser as mentioned in desk study) on the waterward slope. Concrete "U" headwall and trash rack at waterward toe. 5x5-foot concrete distribution box and headwall at landward toe. (USACE-1962). This entry matches the Drainage or Irrigation Structure referenced in O&M manual (HLM 4.87).
FS Date: 3/20/2014

Pipe visible on waterward side.

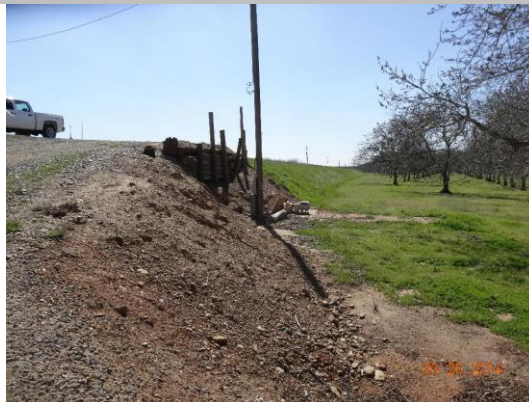
Photo 2 of 3 : UCIP_SP_2017_40049_71926.jpg

Overview of waterward side.

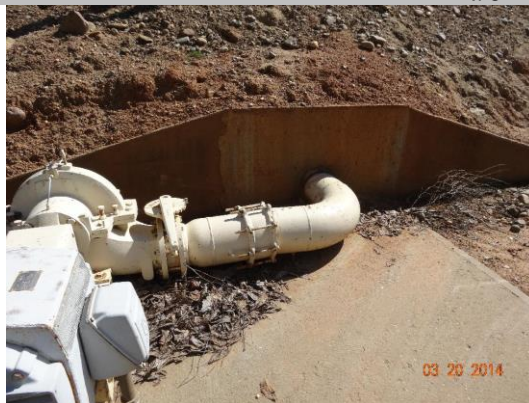
Photo 3 of 3 : UCIP_SP_2017_40049_71932.jpg

Comment Code						
Inspector Comment						
FS_ID:40049 DS_ID:19493 EP_NO: N/A Repair Type: Non-Urgent Crossing Status: Found UCIP Comments: Crossing has been modified---need to contact owner to obtain permit used for modification. FIELD_STRUCT_DESC: 24-inch corrugated metal irrigation pipe through levee, 10.6 feet below the crown. Slide gate in concrete square riser (not 36-inch CM riser as mentioned in desk study) on the waterward slope. Concrete "U" headwall and trash rack at waterward toe. 5x5-foot concrete distribution box and headwall at landward toe. (USACE-1962). This entry matches the Drainage or Irrigation Structure referenced in O&M manual (HLM 4.87). FS Date: 3/20/2014

Pipe connection at crossing.
